## LOW-EARTH ORBIT EFFECTS ON ORGANIC COMPOSITE MATERIALS FLOWN ON LDEF\*

This paper summarizes the findings for organic matrix composites flown on the LDEF and identifies the LEO environmental factors, their effects, and the influence on space hardware design factors for LEO applications.

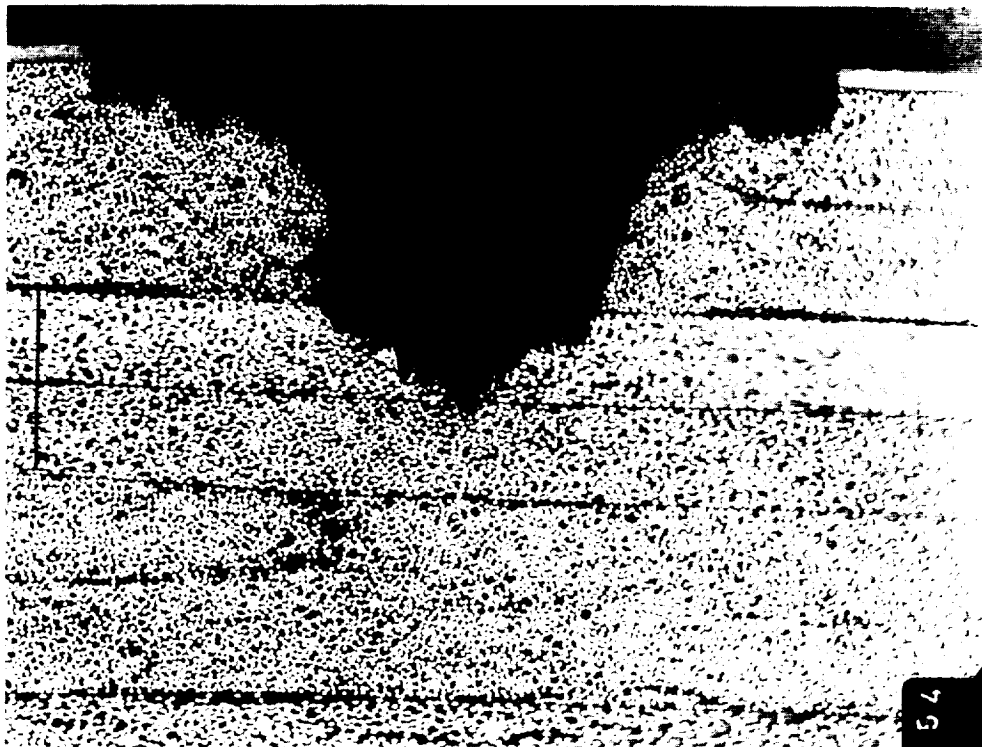
Figure 17. Cross-sectional photomicrograph of coated graphite-reinforced OMC showing impact damage and post-impact AO erosion.

Figure 17 shows a cross-section photomicrograph of an LDEF A-276 coated graphite/epoxy specimen taken from a large panel with a meteoroid or debris impact. Near the sides of the photomicrograph the coating has effectively prevented AO erosion of the substrate. However, at the impact site, in addition to the impact damage, the jagged pattern of AO erosion is plainly visible on exposed OMC surfaces.

The area of the panel effected by these impacts was less than 0.01 percent, and the total volume of the OMC material effected by the impacts and erosion was less than 0.000001 percent. This suggests that OMC's can be adequately protected with coatings for many LEO applications. Straightforward design calculations, based on anticipated meteoroid and debris environments and
